LEAD IN DRINKING WATER REPORT

Manalapan- Englishtown Regional Schools

Inspection Date: 11/23/2024
Project Number: 2490

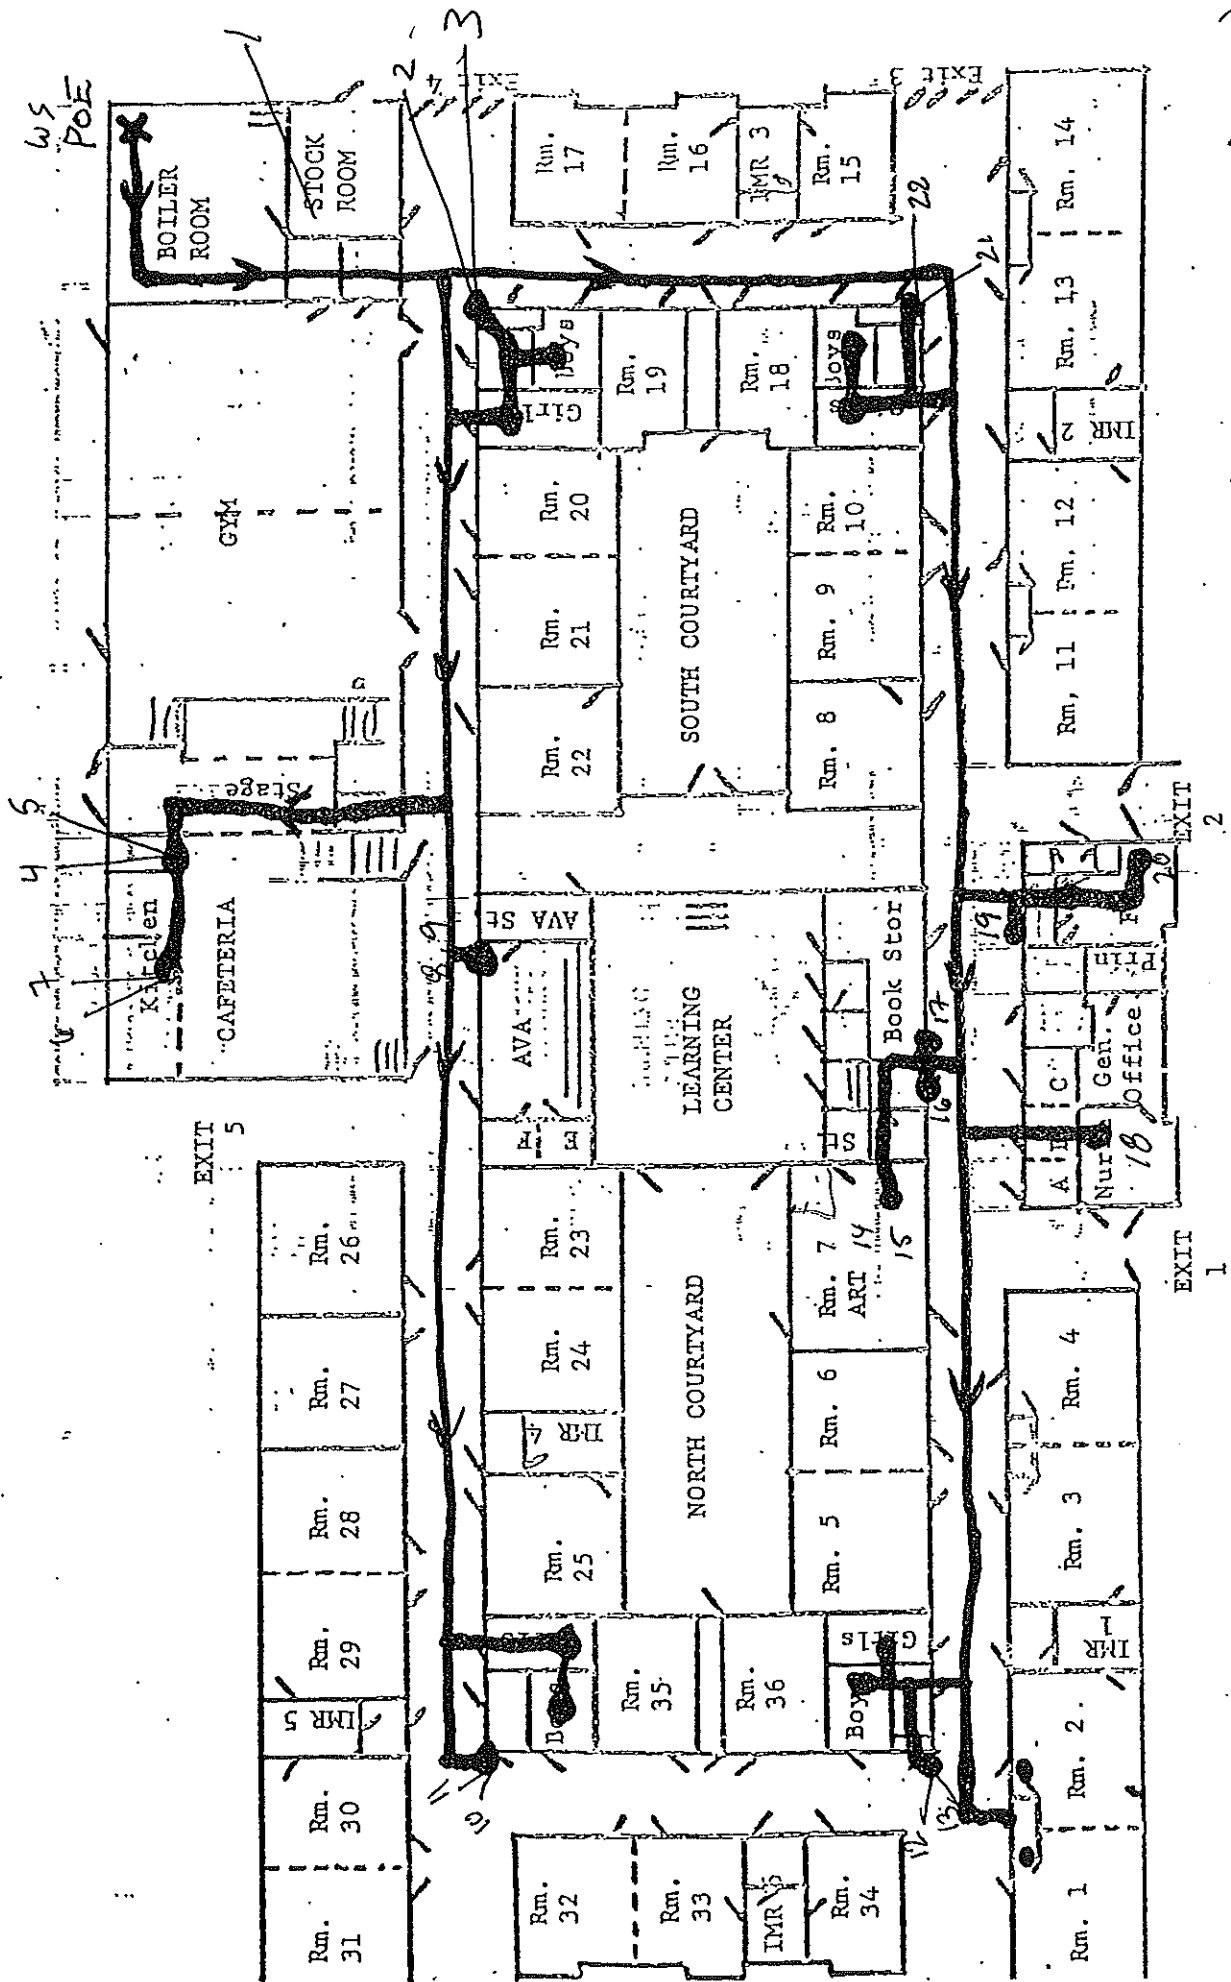
MILFORD BROOK SCHOOL - FLOOR PLAN

- 24 first draw samples collected plus 1 QAQC blank sample
- 1 sample above the 15ppb action level

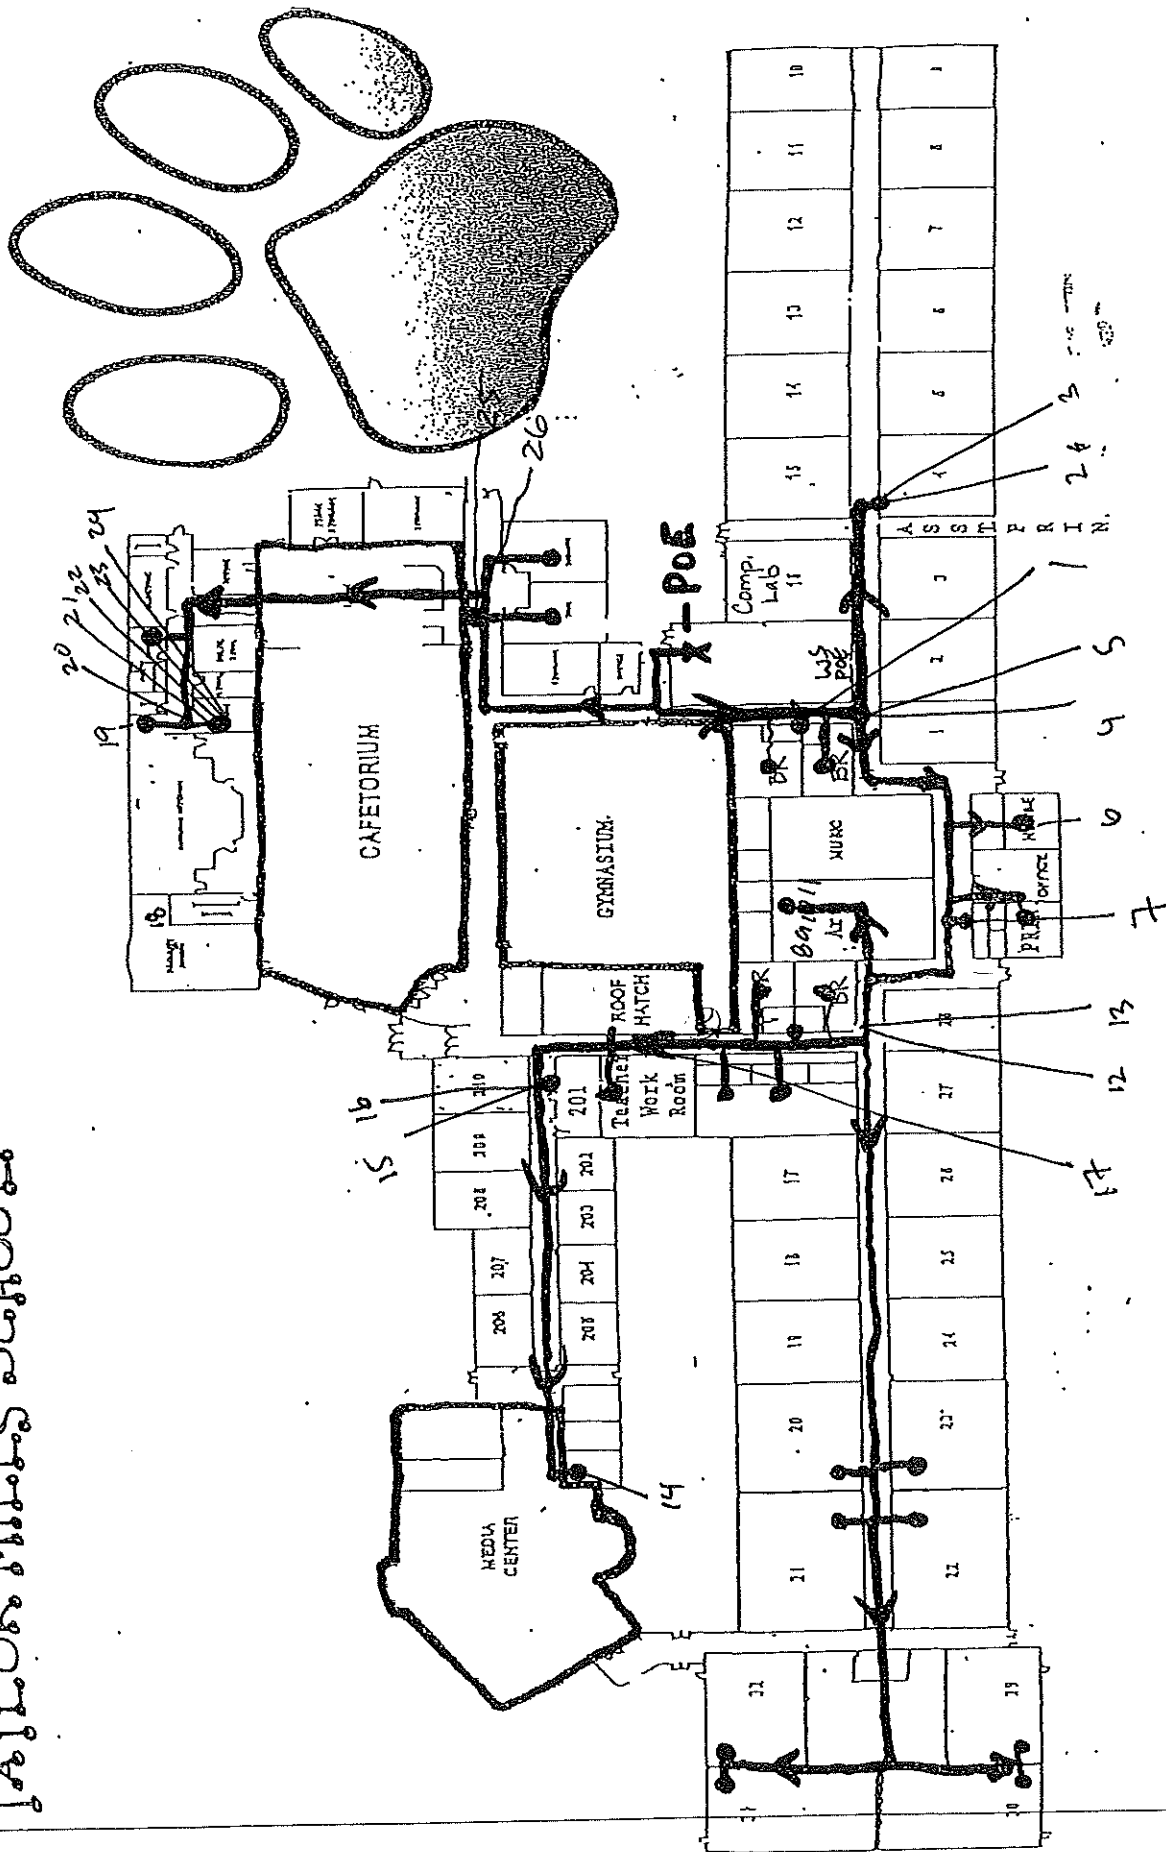
Taylor Mills School

- 28 first draw samples collected plus 1 QAQC blank sample
- 0 samples above the 15ppb action level

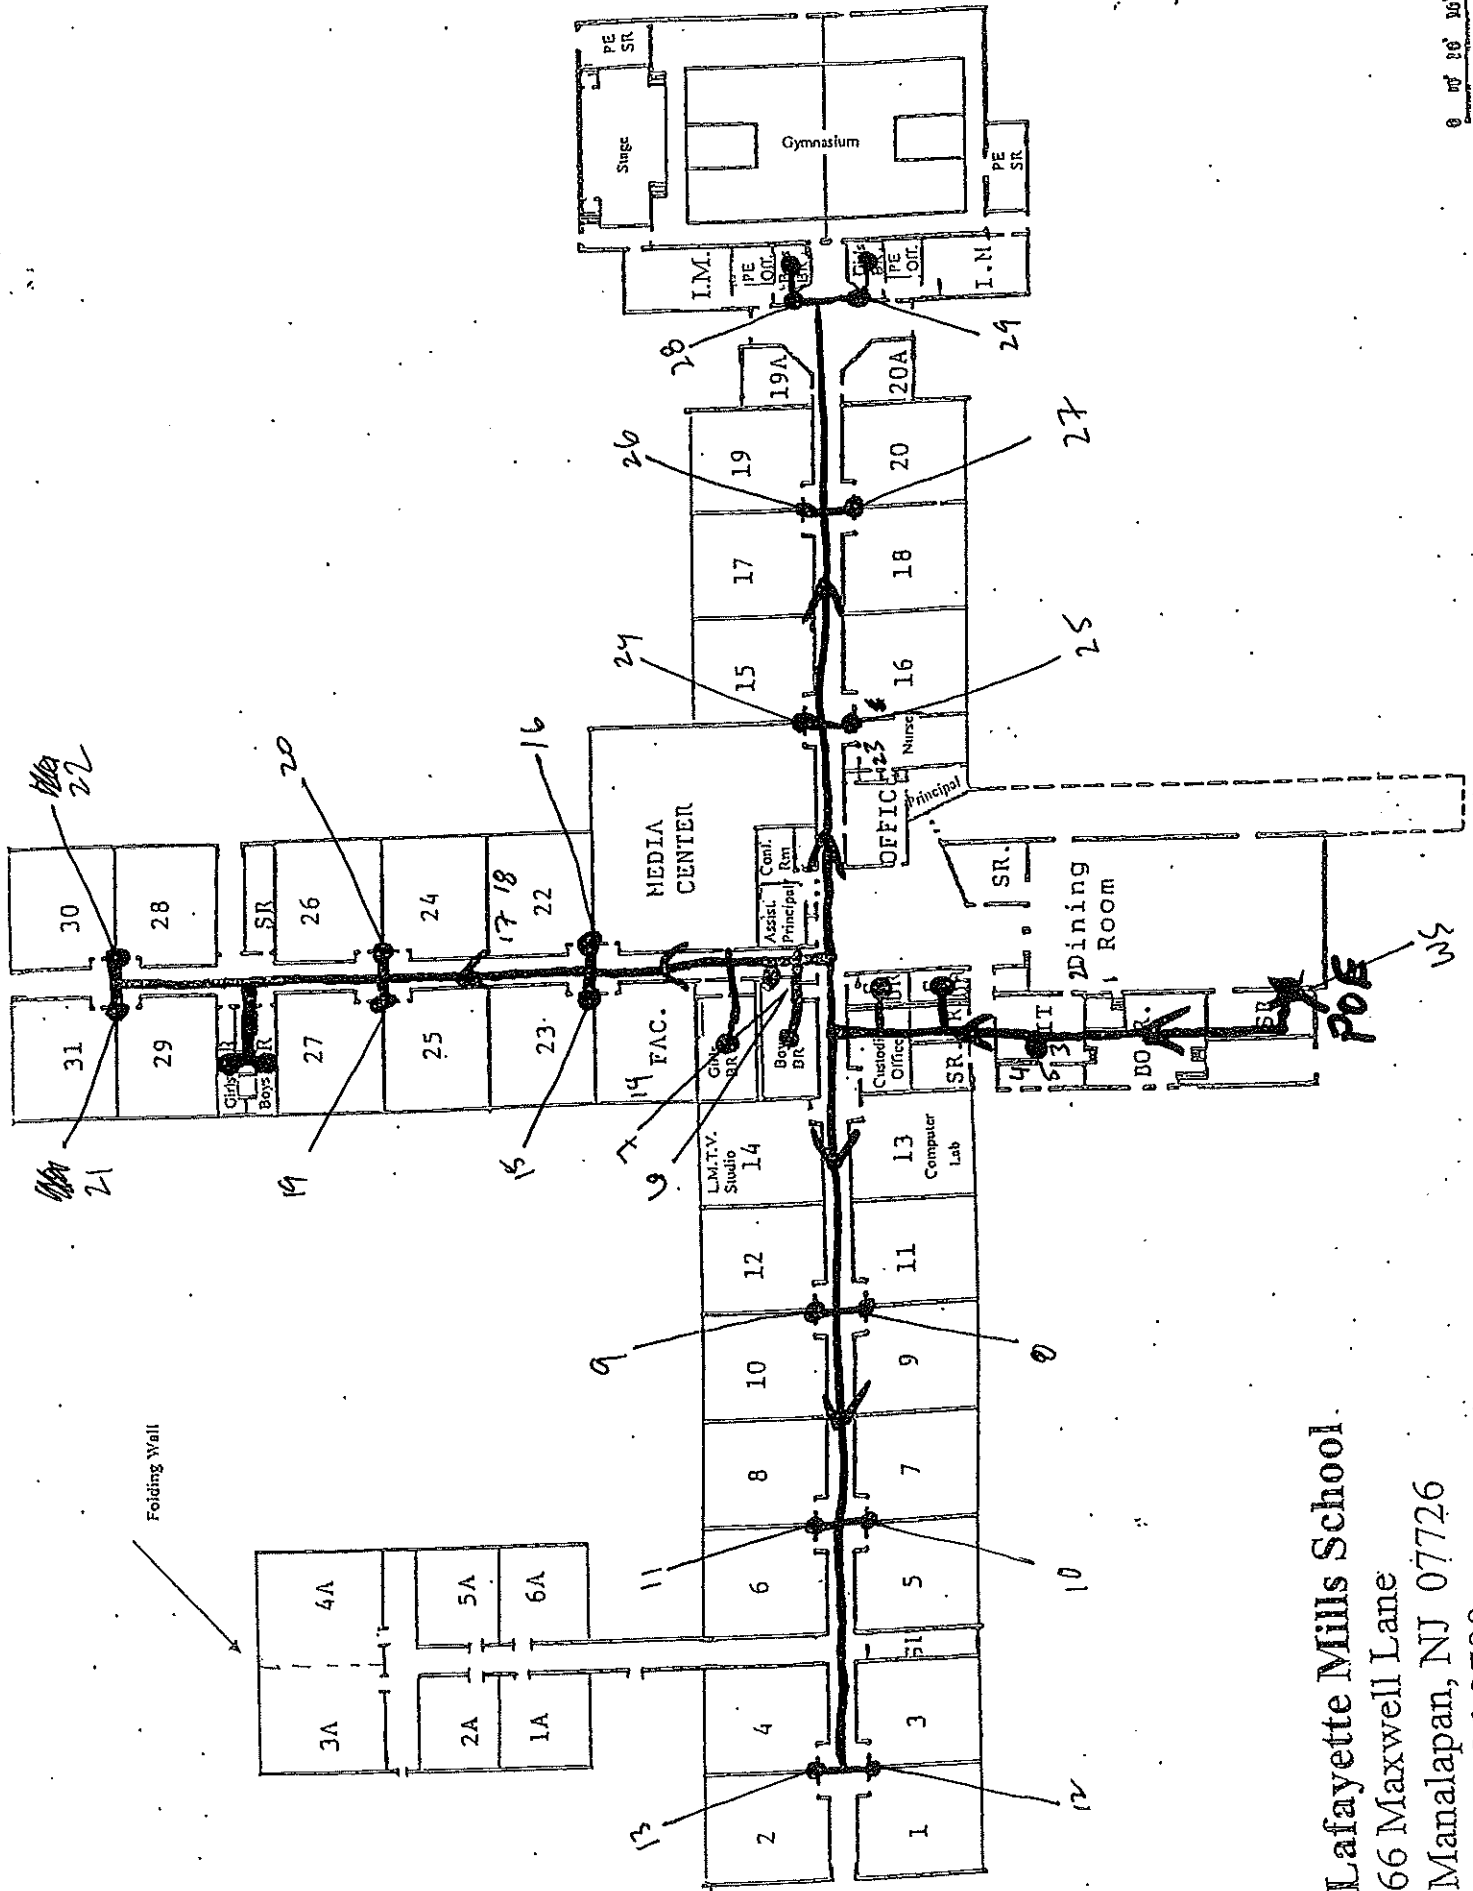
Lafayette Mills School
 66 Maxwell Lane
 Manalapan, NJ 07726
 (732) 786-2700

- 29 first draw samples collected plus 1 QAQC blank sample
- 2 samples above the 15ppb action level

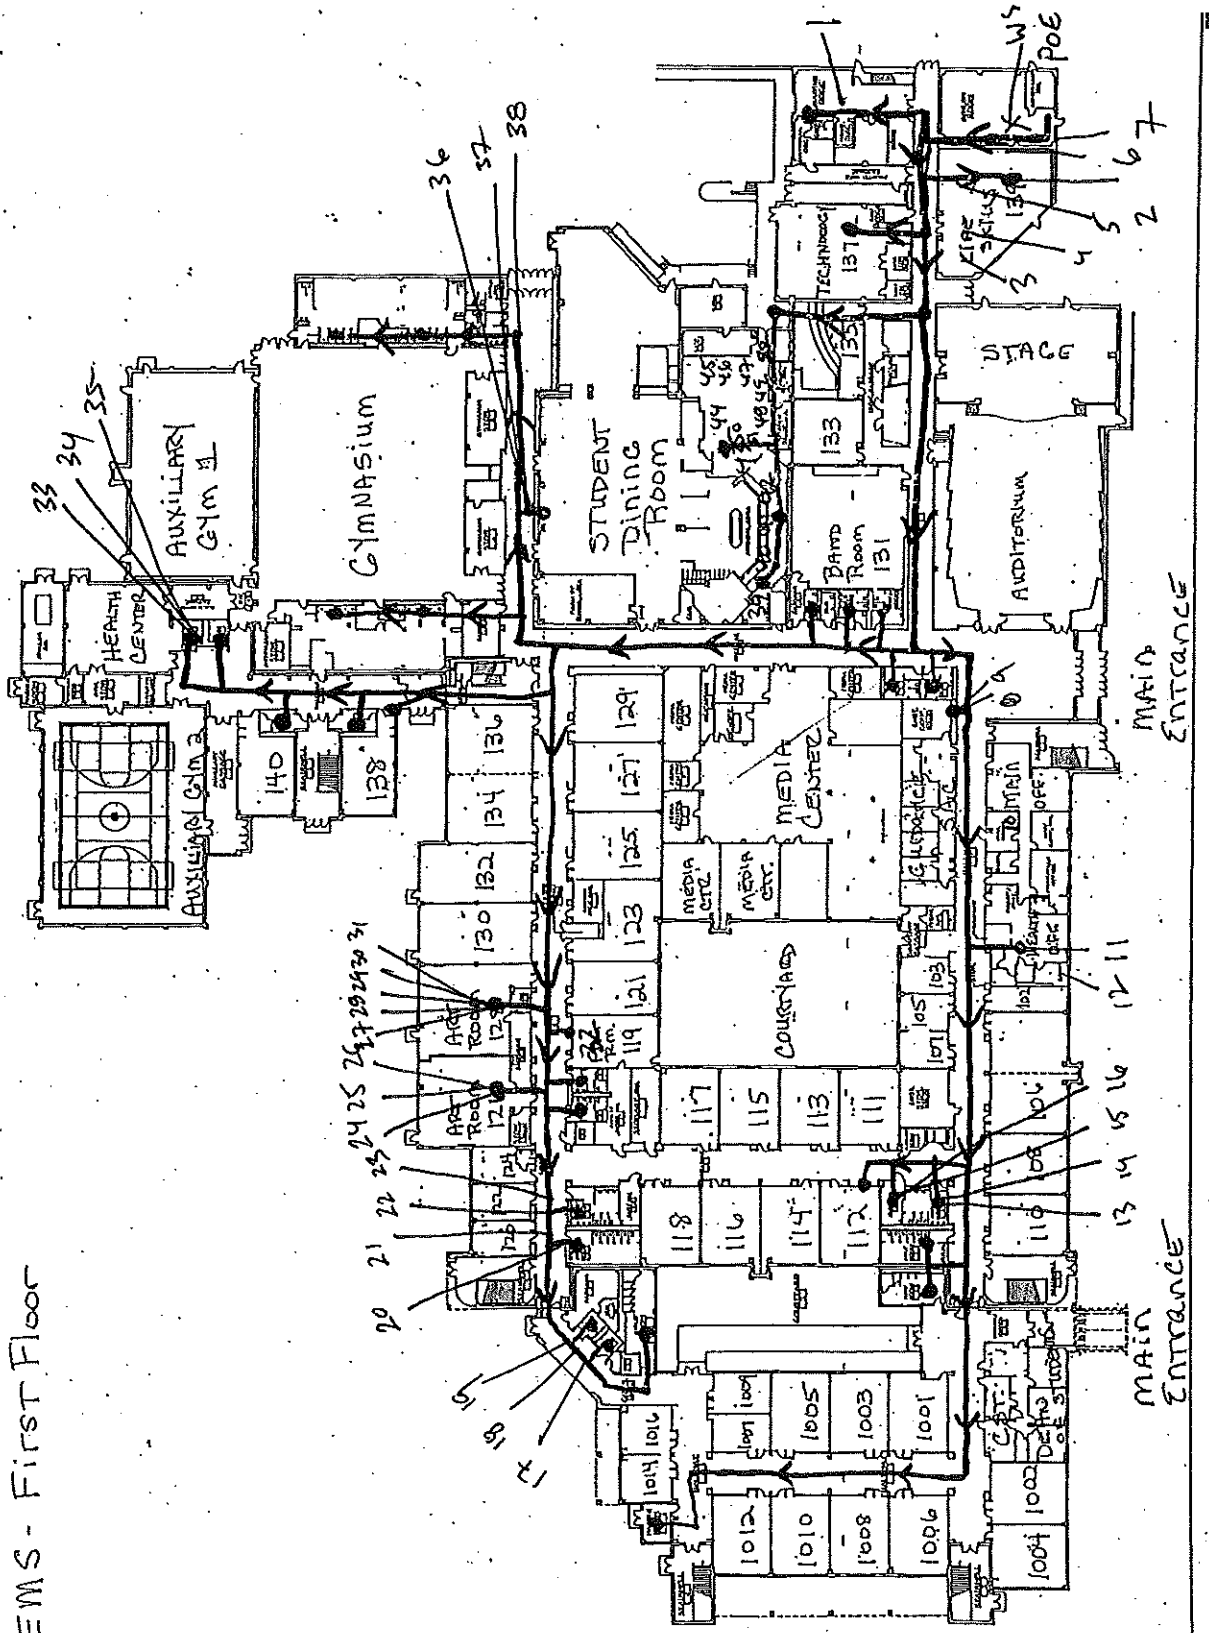
MEMS - First Floor

- 59 first draw samples collected plus 1 QAQC blank sample
- 1 samples above the 15ppb action level

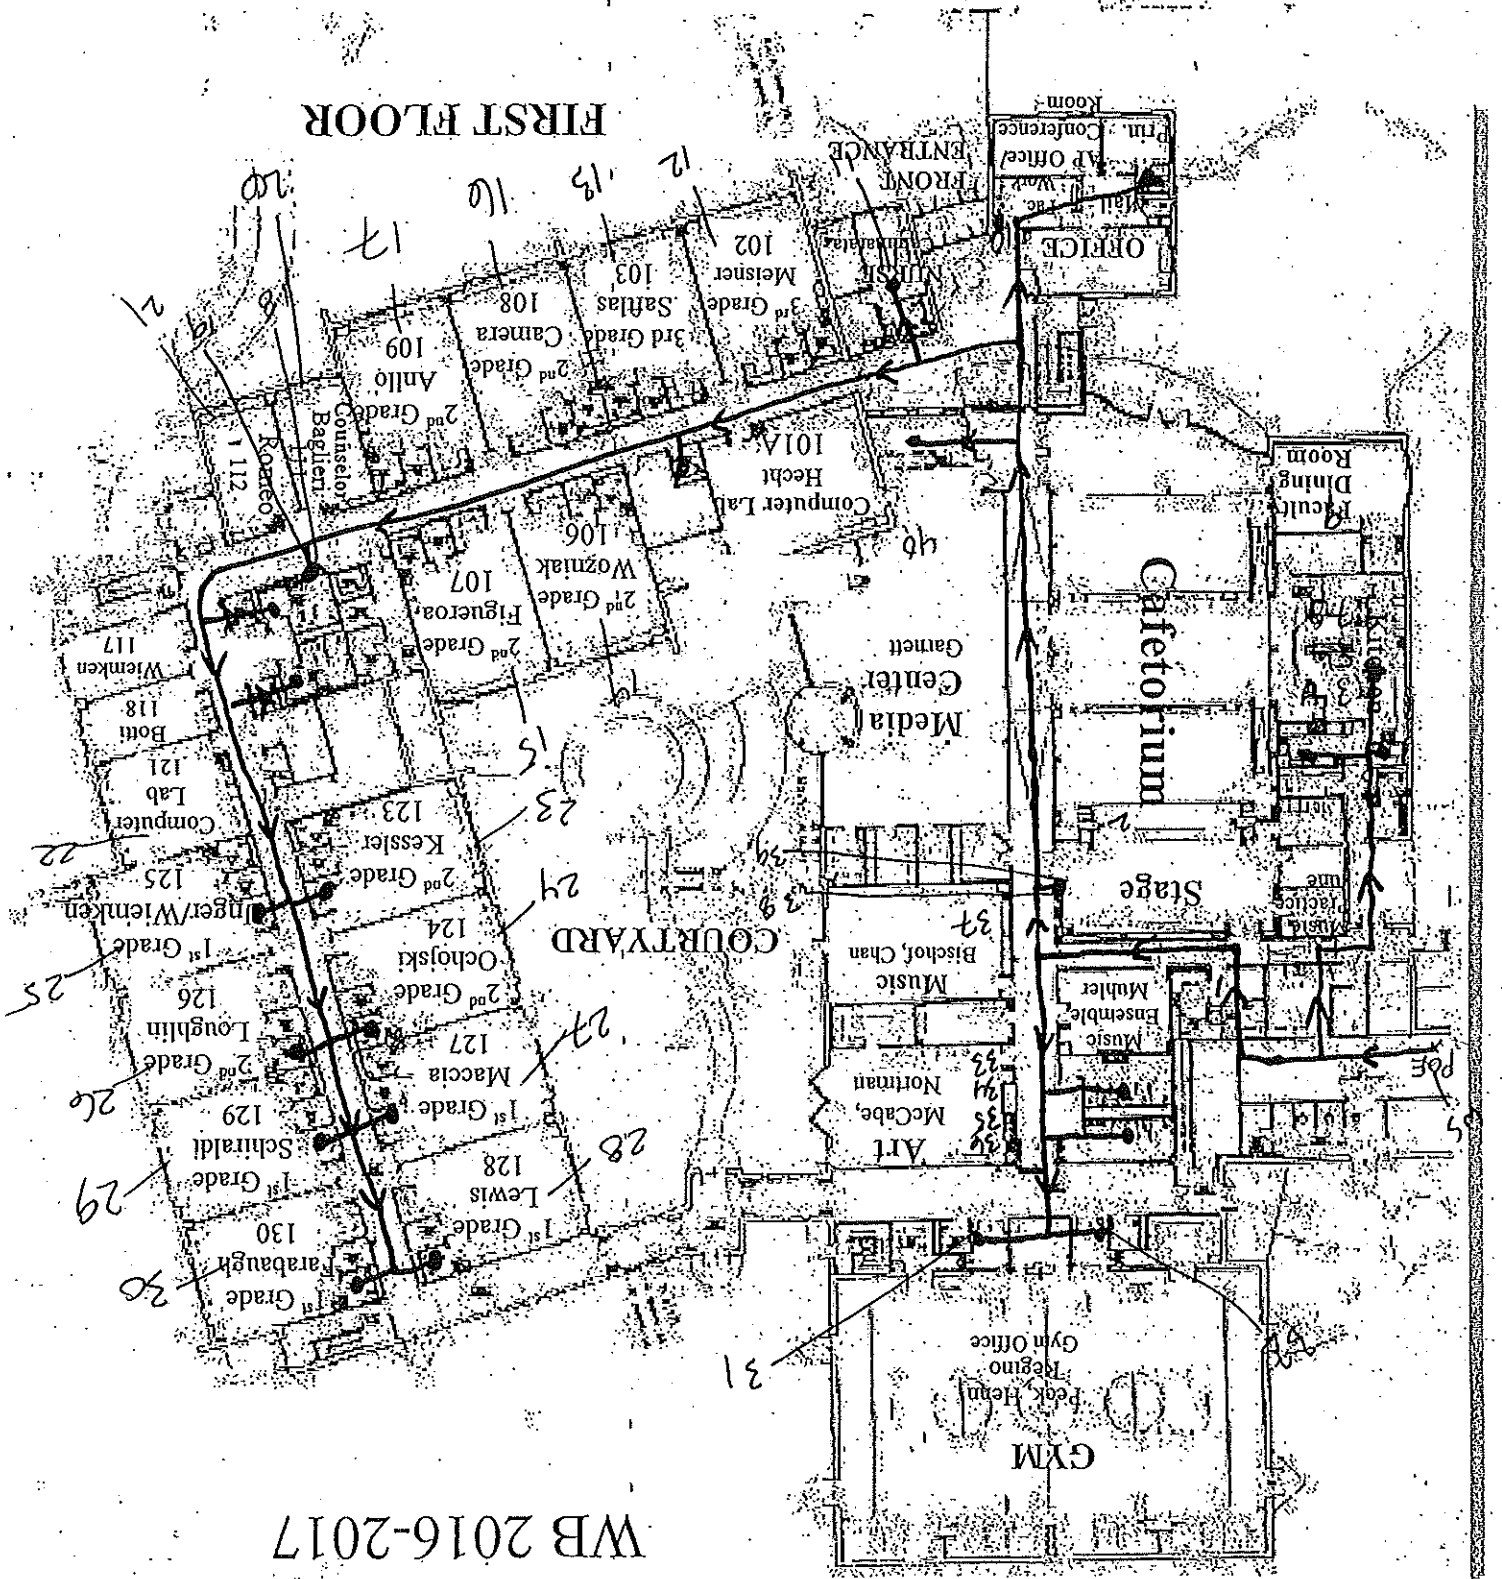
FIRST FLOOR

- 64 first draw samples collected plus 1 QAQC blank sample
- 2 samples above the 15ppb action level

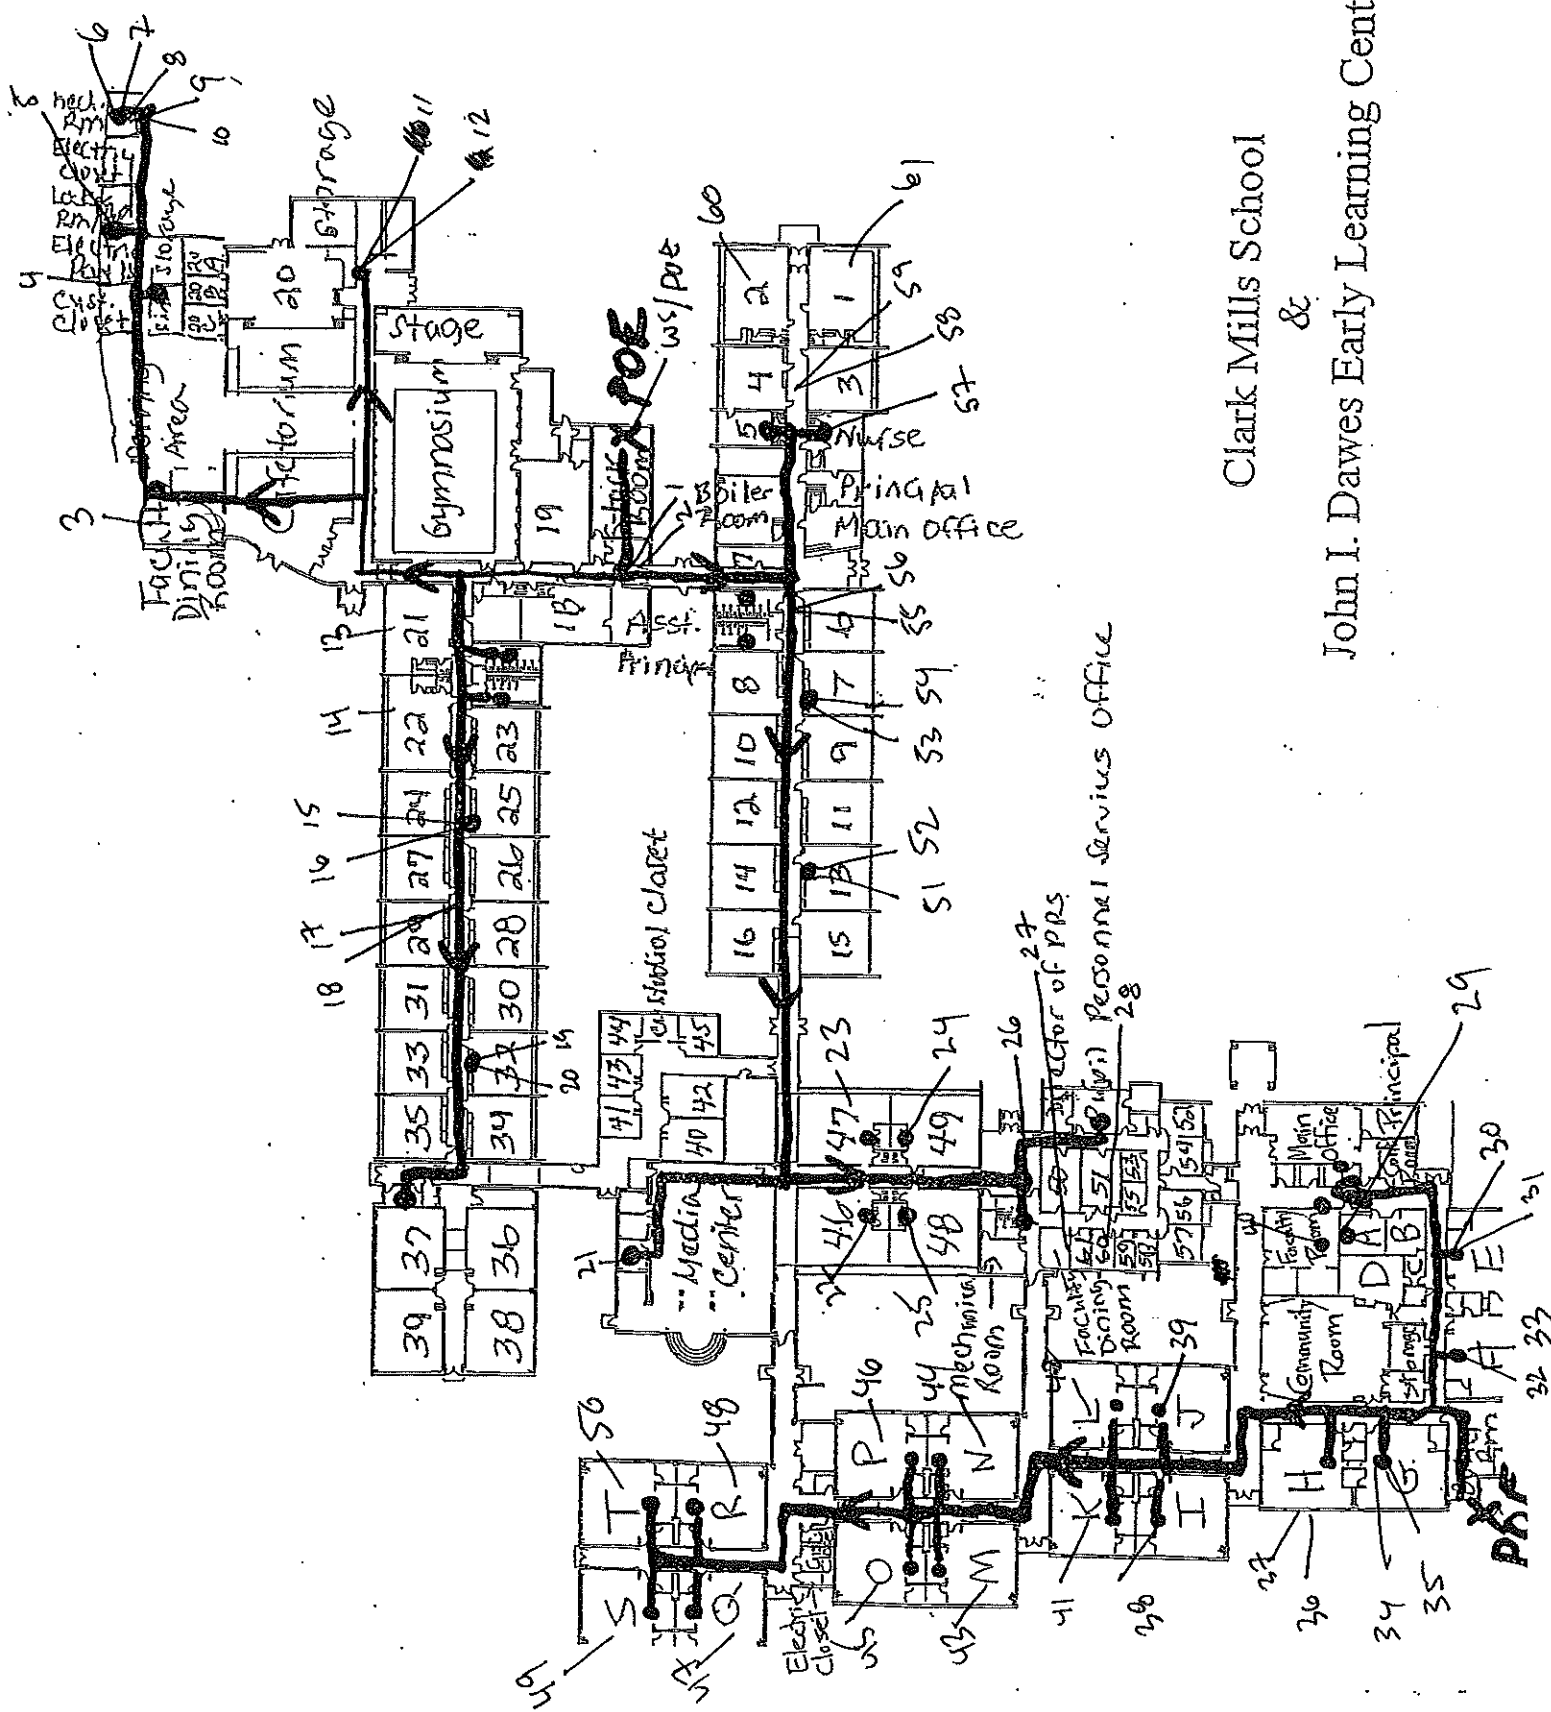
Clark Mills School
&
John I. Dawes Early Learning Center

- 49 first draw samples collected plus 1 QAQC blank sample
- 1 sample above the 15ppb action level
